GVSU Storm Water Monitoring Data Summary, Progress Report, and Recommendations

Dr. Peter J. Wampler
Grand Valley State University
Geology Department

Final report submitted to GVSU Facilities Management August 2009

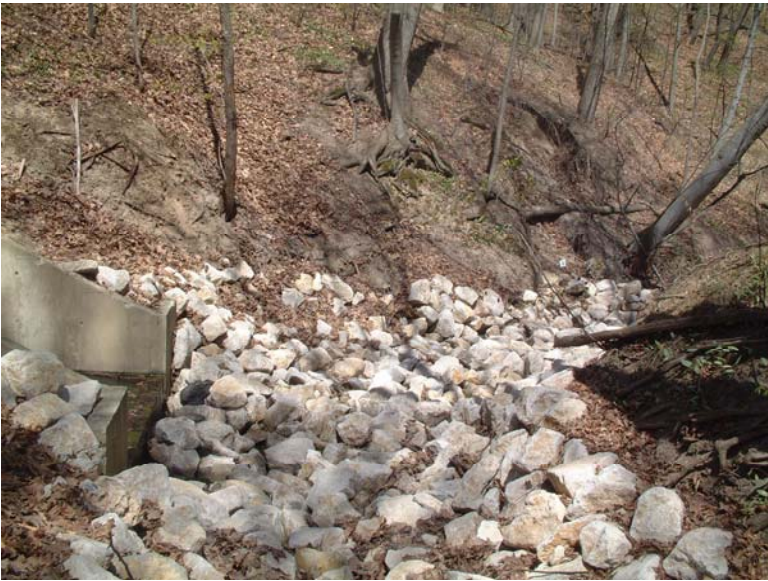
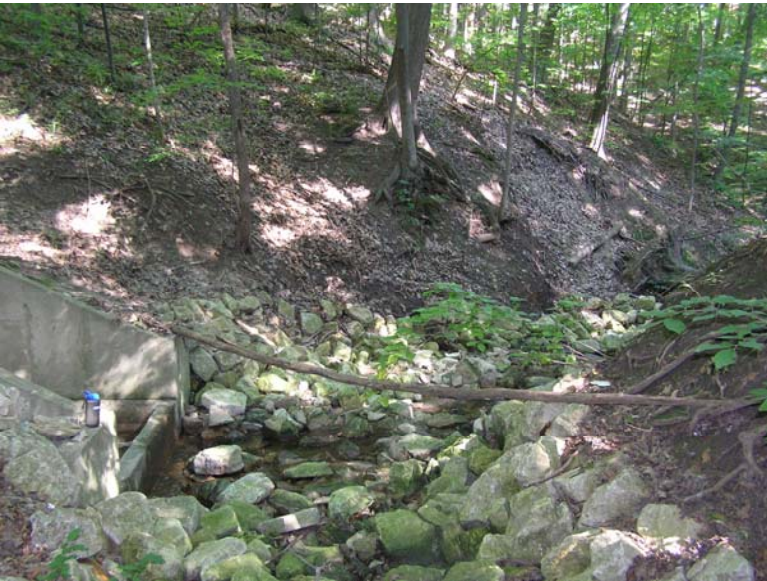
Location	Before (date)	After (date)	Comments
Little Mac Ravine at Energy Dissipation structure

7/31/08	The energy dissipation structure seems to be functioning to dissipate energy. The rip rap channel protection install below the structure us slowly being eroded away and is also mechanically breaking down due to the friability of the limestone chosen for the fill. The mechanical breakdown of the rock has been beneficial in the short term because it has created a wider range of grain size and allowed the materials to key into the channel and prevent future erosion.
Downstream of the Little Mac Ravine Energy Dissipation structure

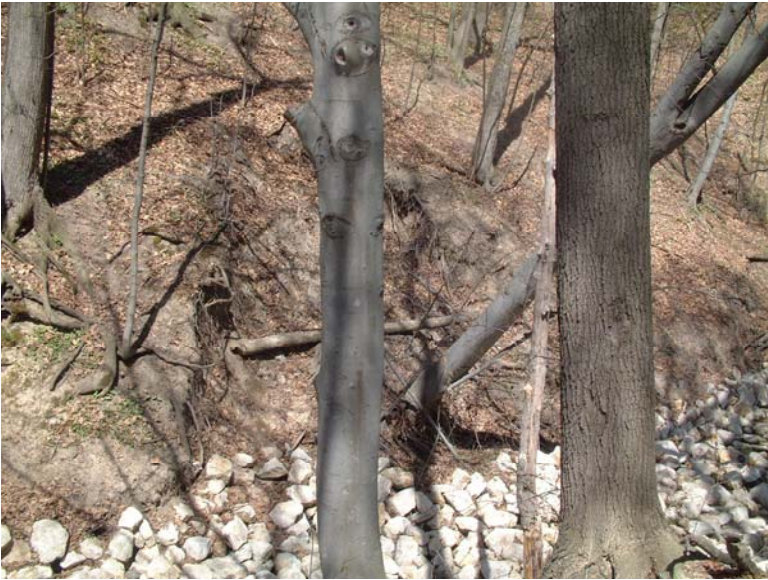
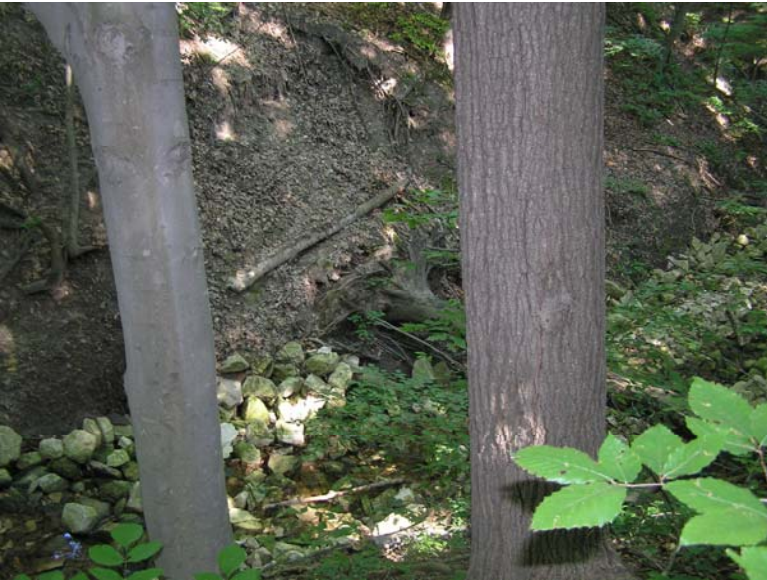
7/31/08	As demonstrated by the photos, the rip rap is not preventing continued erosion of side slopes and slumping of materials down the slope. The tree which was leaning over in 2003 has fallen and is currently spanning the ravine. At this location and others it is clear that during storm events the rip rap is overtopped by water levels.

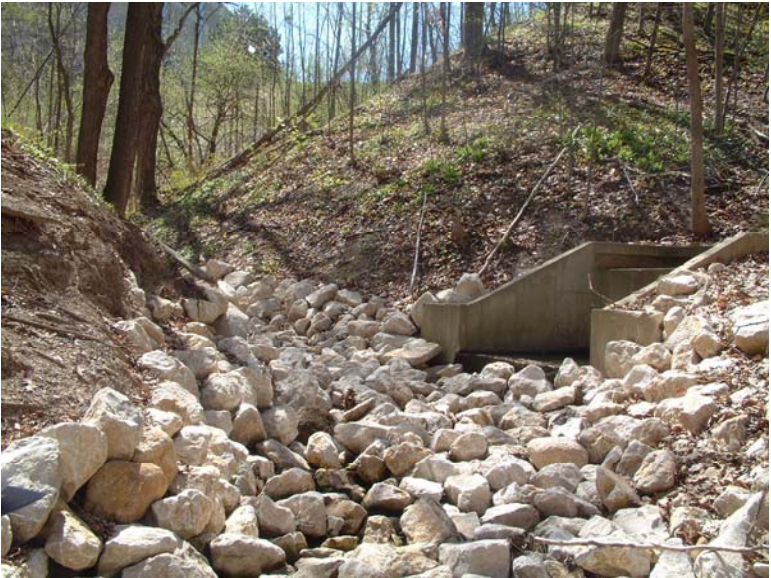
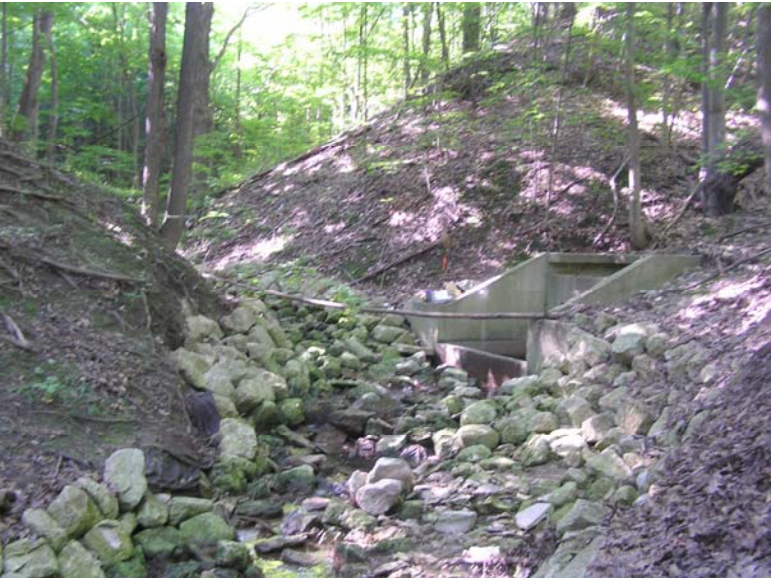
Location	Before (date)	After (date)	Comments
Little Mac Ravine at Energy Dissipation structure	<div>

<p>7/31/08</p></div>	This set of photos highlights the channel development due to the settling and mechanical breakdown of the rip/rap materials added to protect the channel from erosion. Algae is also prominent suggesting excess nutrients in the storm water.
Downstream of the Little Mac Ravine Energy Dissipation structure	<div>

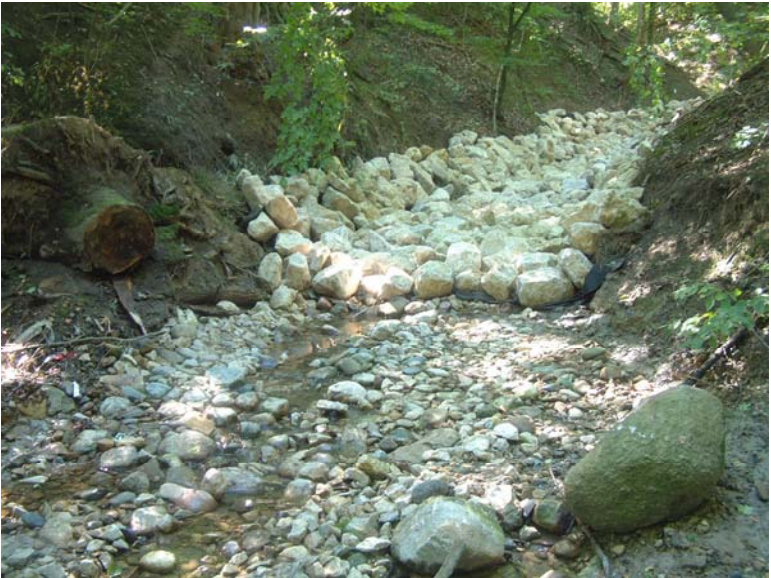
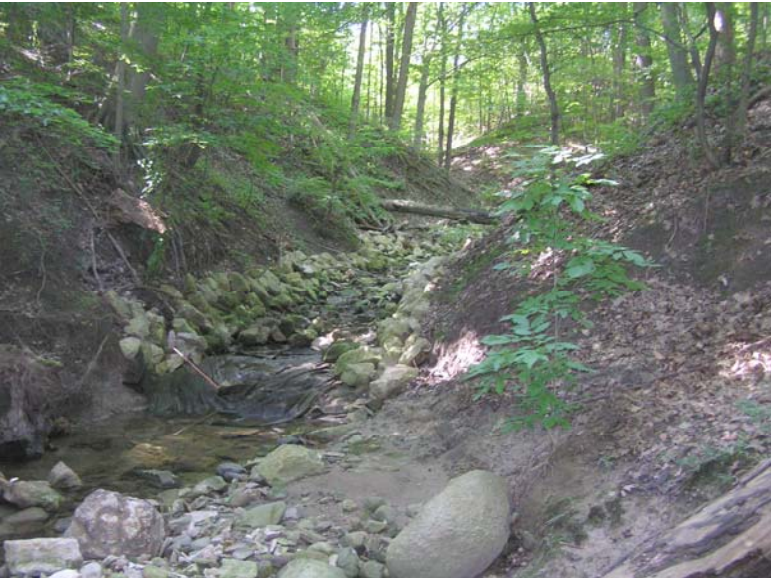
<p>7/31/08</p></div>	The downstream terminus of the rip/rap structure continues to erode away. Rocks are slowly being eroded and removed from the geotextile liner. Smaller rocks and cobbles are being eroded downstream below the channel protection creating a small pool.

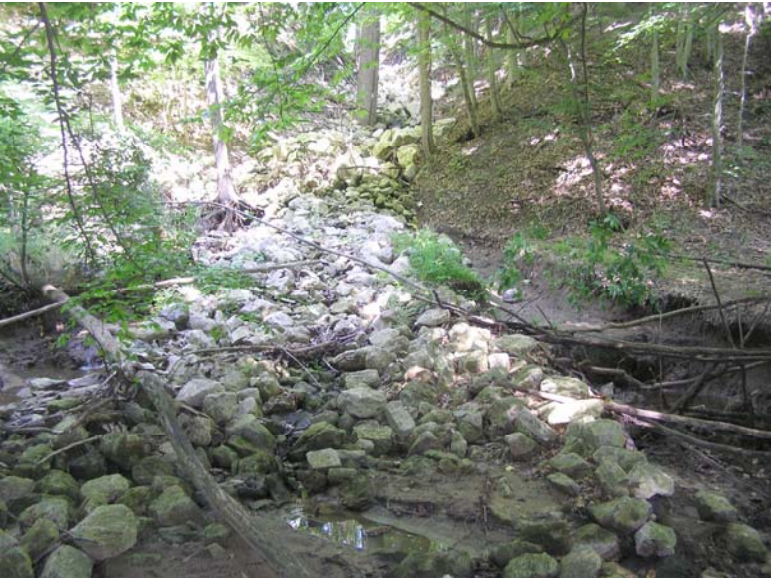
Location	Before (date)	After (date)	Comments
Calder Main Drain below Calder Arts Building. Looking up from the ravine bottom.

7/31/08	The rip rap channel protection installed below the storm water outlet structure continues to be eroded away, especially near the bottom where the flow expands into the ravine floodplain. This has resulted in a 1-2 meter deep gully on the right side of these photos (see below). This process will likely continue to cause lateral erosion.
Calder Main Drain below Calder Arts Building. Looking down on the downstream side of the rip/rap.

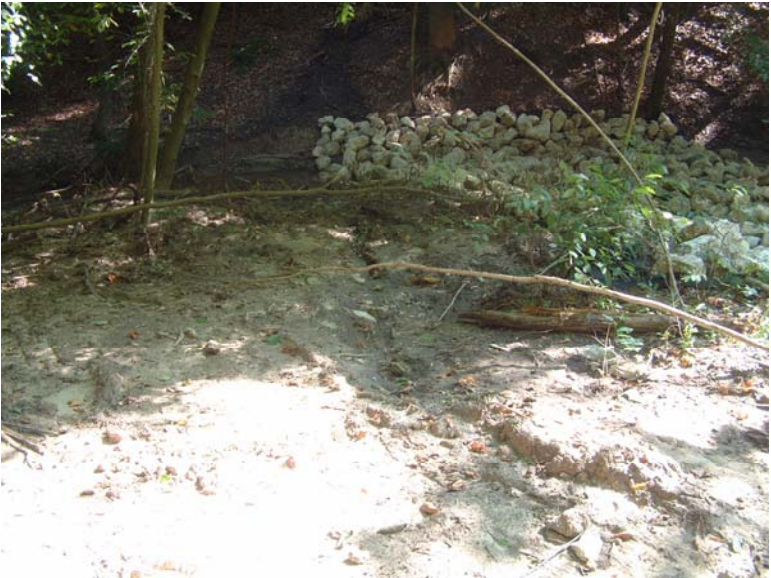
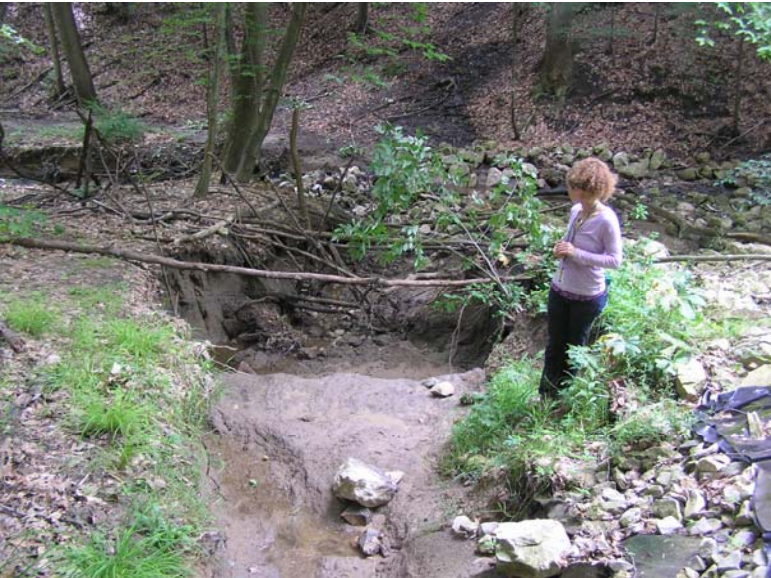
7/11/08	The rip rap channel protection installed below the storm water outlet structure continues to be eroded away, especially near the bottom where the flow expands into the ravine floodplain. This has resulted in a 1-2 meter deep gully on the left side of these photos. This process will likely continue to cause lateral erosion and will eventually undermine all of the rip/rap protection.
