GVSU Storm Water Monitoring Data Summary, Progress Report, and Recommendations

Dr. Peter J. Wampler
Grand Valley State University
Geology Department

Final report submitted to GVSU Facilities Management August 2009

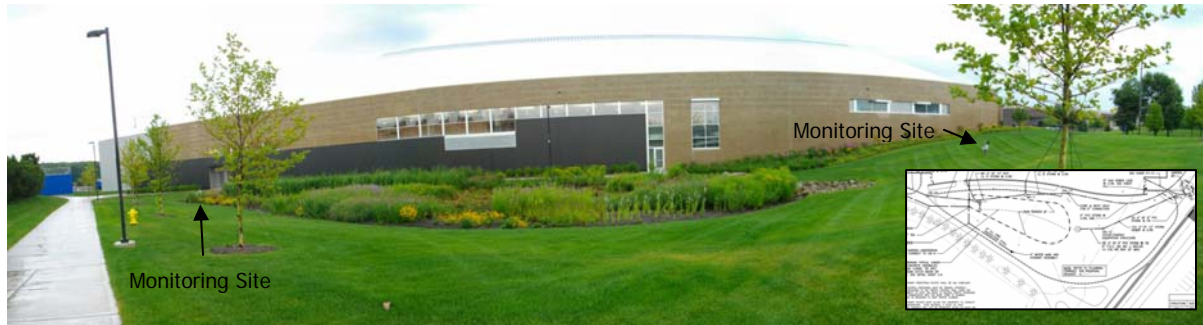
Figure 3. Photo of the Rain Garden and monitoring sites located near the Turf Building. Inset is the construction plan for the Rain Garden.

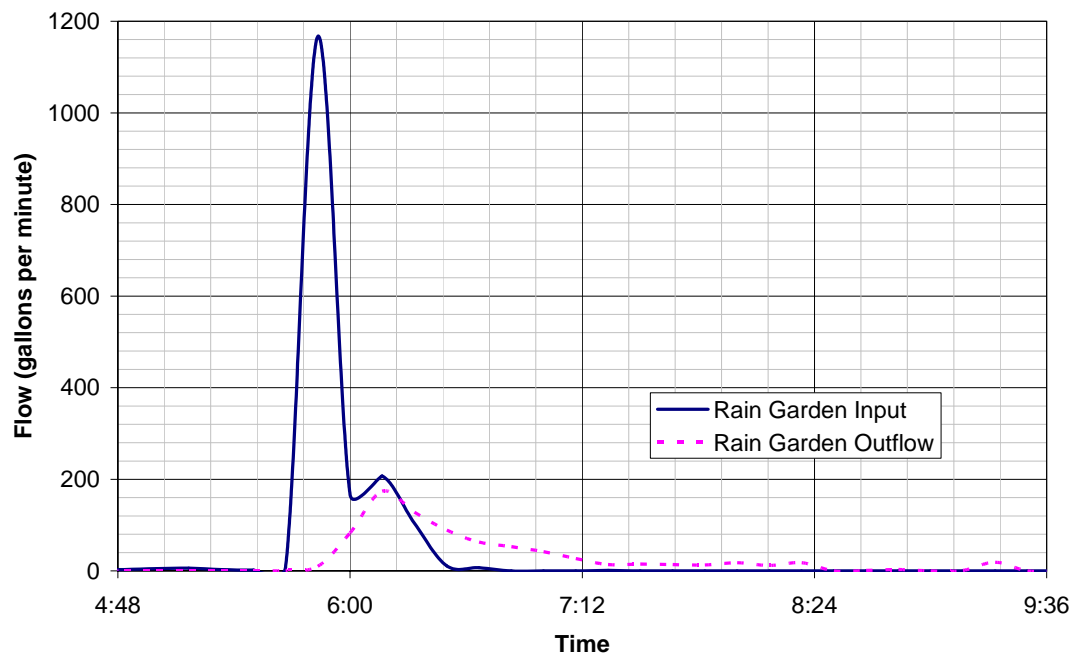
Turf Building Rain Garden - 7/11/09 Rain Event

Figure 4. Example of reduction flow as a result of the installation a large rain garden near the Turf Building, GVSU.

5. The Turf building rain garden has demonstrated that rain gardens are an effective and aesthetically pleasing way to treat storm water. Additional rain garden features are needed throughout campus.
